Withings Activé Pop Smartwatch Teardown

This guide is for the complete teardown of Withings Activé Pop Smartwatch , showing the individual components and parts during the process.

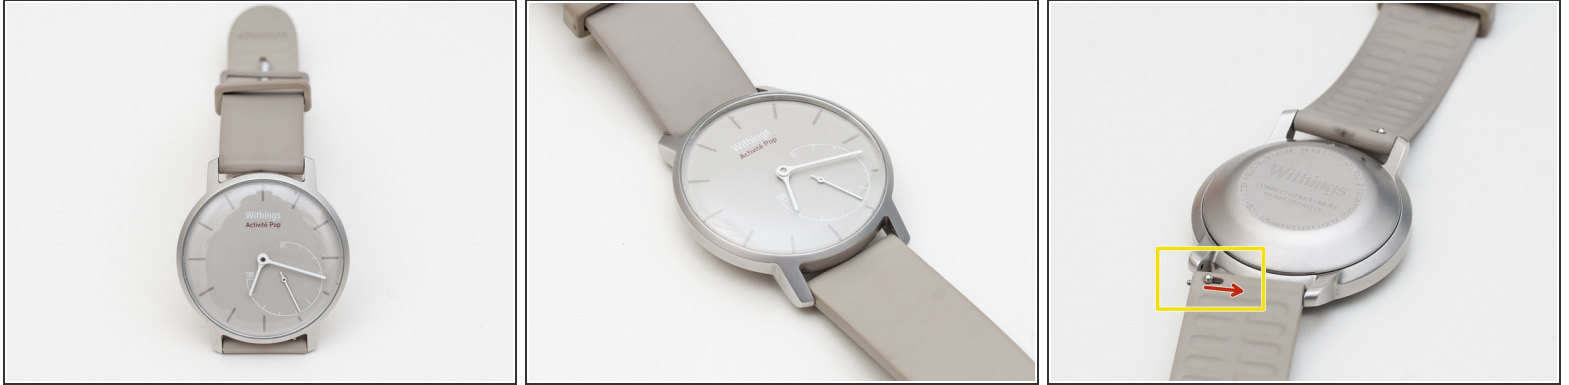
Step 1 — Introduction, remove the rubber band

- This is Withings Activité Pop Smartwatch. A beautifully designed no frills smartwatch that shows your daily activity score with an analogue gauge. Remove the rubber band by pulling tiny levers at the back along arrow direction.

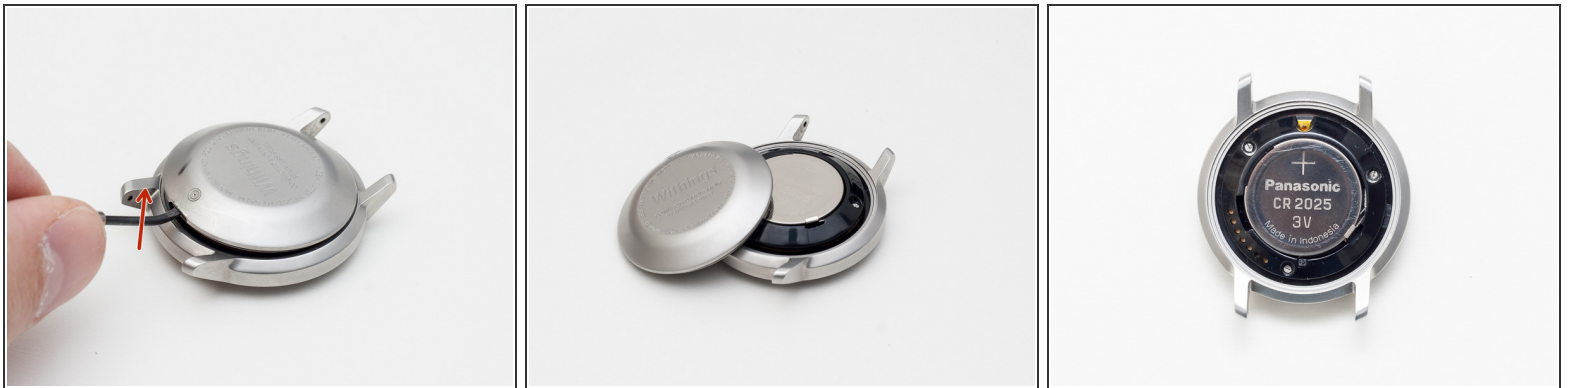
Step 2 — Remove case back and access the battery

- The case back can be opened by prying with the opening tool or a flat screwdriver. You will see the CR2025 lithium battery shining with all its glory.

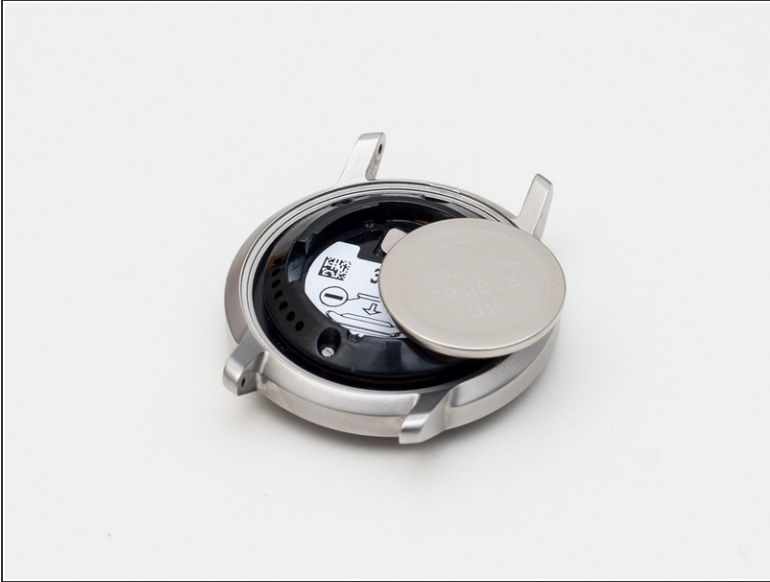
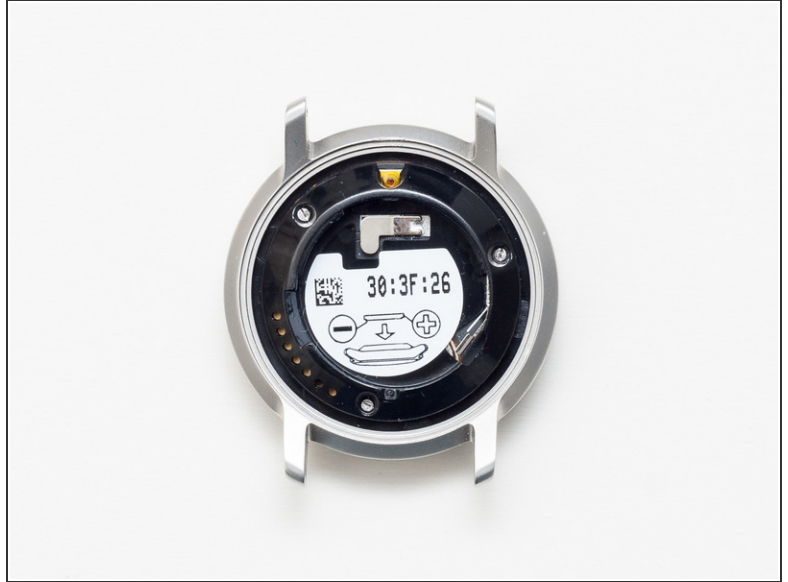
Step 3 — Remove the lithium battery

- Pry the CR2025 lithium battery off and ponder the meaning of three hexadecimal numbers on the information sticker.

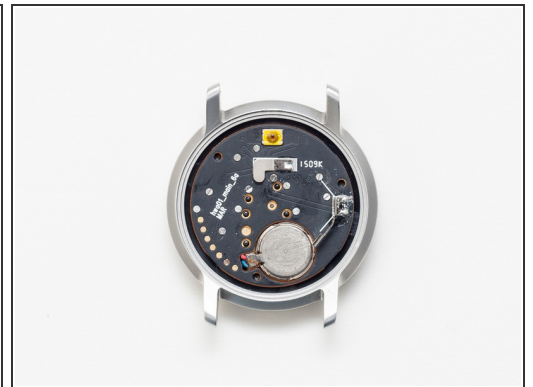
Step 4 — Remove the inner plastic cover

- Using a thin flat blade screwdriver remove three self tapping screws holding the inner plastic cover. The vibration motor (round metal part in second photo) has a sticky tape on it. You may need to apply force to separate the motor from the inner plastic cover. See the main PCB.

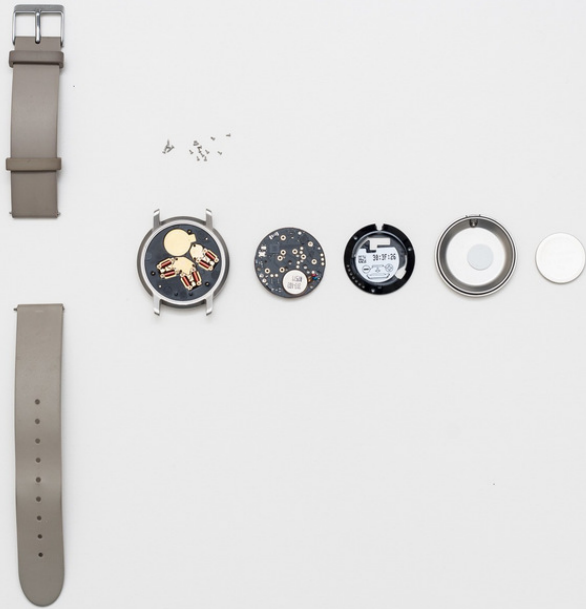
Step 8 — Teardown complete...

- This Withings Activé Pop Smartwatch had water ingress and it failed due to corrosion. A common fault with this watch is loose inner screws, leading to poor PCB contact with motors. When you change battery make sure you apply silicone grease on the rubber gasket of the case back. The dial and hands are not accessible since the glass is pressed.
